Laboratory Glass Impact Test Report (BS EN 12600)

Sample type: 6mm thick, tempered glass

Test sponsor: Safe Lite Glass Industries LLC

Report number: DLR2231

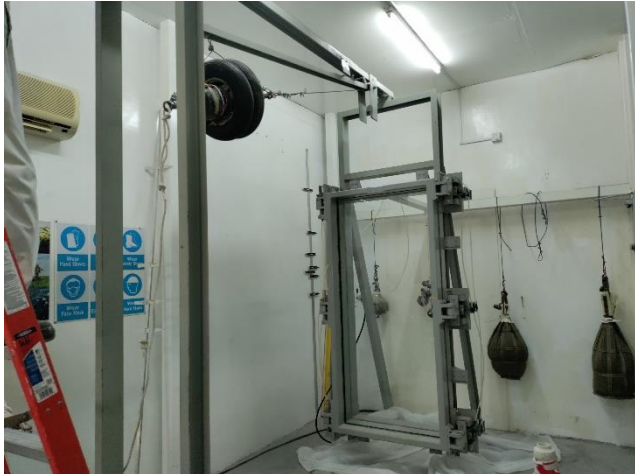
Photo no.	Description	Photograph
1	Impact test set-up.

The test apparatus comprised of a main frame and a clamping frame which was fitted to the main frame which was used to hold the test piece in position for the duration of the test and a dual tyre impactor with suspension device and release mechanism. The total mass of the impactor was 50 kg.

The test piece was securely clamped in the sub-frame, the impactor was positioned such that it was hanging at rest, at the centre of the test piece, between 5 to 15 mm from the surface.

The impactor was raised to a drop height of 190 mm and released.
